**SEISMIC BEHAVIOR OF BEAM COLUMN JOINTS STRENGTHENED
WITH ULTRA HIGH PERFORMANCE CONCRETE**

A Thesis Presented to the
DEANSHIP OF GRADUATE STUDIES

KING FAHD UNIVERSITY OF PETROLEUM & MINERALS

MAY 2017

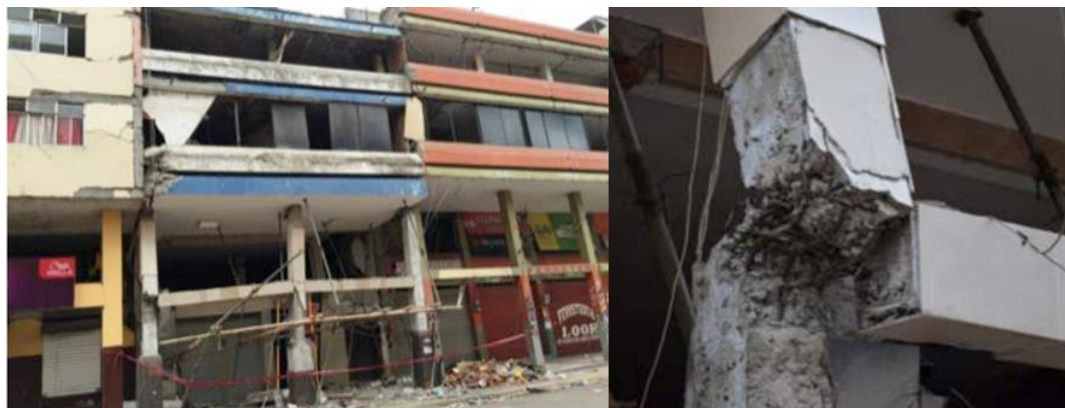
Figure 1-2 Collapse of three story RC frame structure due to BCJ Failure[5]

Three story RC frame structure collapsed partially when an earthquake struck Ecuador due to BCJ failure as shown in Figure 1-2. Nepal experienced a powerful earthquake in Gorkha and Kathmandu. Investigation team reported soft story collapse of RC building in Sitapaila, Kathmandu. They observed that no stirrups were provided in the joint region as shown in Figure 1-3. Several BCJ failures which resulted in the collapse of the structure, had been found by Serra Zerrin Korkmaz after Van Earthquake struck Turkey, as shown in Figure 1-4. Approximately, 2000 RC buildings had been affected due to Van Earthquake. BCJ failure in RC frame structures resulted in excessive drift or collapse of buildings. Post-earthquake investigation showed that these buildings were either collapsed or damaged beyond their repair.

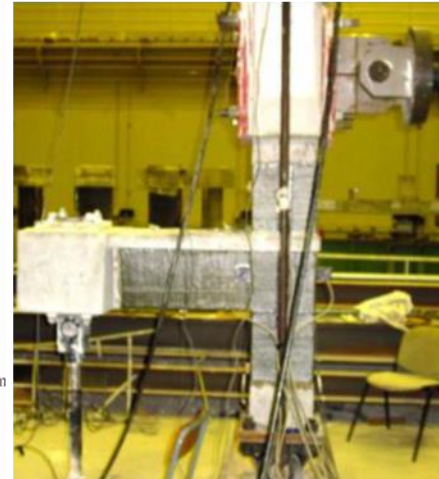
Figure 2-1 Schematic representation of Scheme # 1 [14]

Saleh et al. (2010) [14] studied the seismic response of FRP-Upgraded exterior BCJs. The total experimental matrix consisted of 4 seismically deficit BCJs sub-assemblages. Of these, two specimens were strengthened with CFRP using two different schemes. In the first scheme, CFRP was wrapped with epoxy on joint, beam and column portions as shown in Figure 2-1, while in the second scheme, CFRP sheet was epoxy bonded on the joint region only and the author introduced the mechanical anchorages in order to provide the prevention against any possible de-bonding of CFRP from substrate (labeled as ES1 and ES2) as shown in Figure 2-2. The remaining two specimens were the control one (labeled as EC1 and EC2). Once damaged, repaired them under the above-mentioned schemes after filling the cracks with epoxy (labeled as ER1 and ER2). All specimens have same geometry and reinforcement detailing. All specimen were subjected to reverse cyclic loading. It was reported that the peak load for EC1 and EC2 was 47.08 kN and 45.8 kN respectively. These values become 62.34 kN and 58.11 kN for ES1 and ES2 specimens and the peak load reached to 81.79 kN and 58.63 kN for ER1 and ER2 specimens. Results showed the enhancement in the peak load values after strengthening and repairing of specimens. Stiffness degradation data showed that for scheme #1, the initial stiffness of retrofitted specimen was higher than the reference specimens, while in Scheme #2, these values were

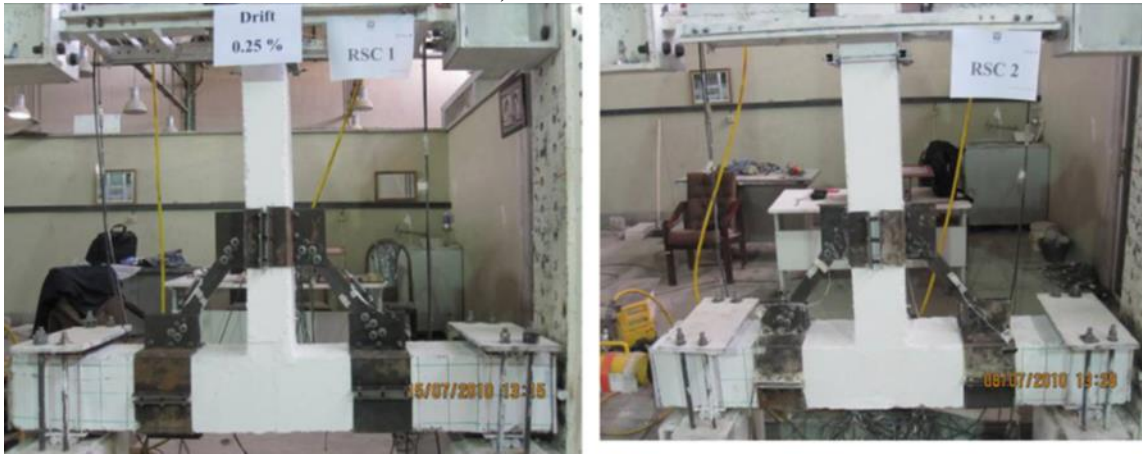
Figure 2-3 Pictorial view of retrofitted specimens RSC1 and RSC2 [15]

Kazem et al. (2011)[15] experimentally investigated the performance of damaged RC exterior BCJ specimens repaired with steel elements including steel prop and curb. In this research work, different RC frames had been inspected and found out that their beam depths were less than the required depths based on the guidelines provided by design codes which resulted into the increasing drift under lateral loads and increasing vertical deflection against gravity loads. The author investigated that this method of retrofitting was suitable for such deficit frames. For this purpose, two half-scale exterior BCJs labeled as SC1 and SC2 used as reference specimens. Specimen SC2 had standard beam height. However, specimen SC1 had reduced beam height. These specimens were tested under reversed cyclic loading. Once damaged, repaired with the same type of concrete and then retrofitted with steel elements. These repaired specimens are designated as RSC1 and RSC2. Retrofitted schemes of these specimens are shown in Figure 2-3. The results showed that the average increase in the ultimate strength of specimen RSC1 relative to its control specimen was 86% and for specimen RSC2 this value reached to 156%. The ultimate rigidity of control specimens SC1 and SC2 were 0.17 and 0.19. By the up gradation of these specimens, the rigidity of these specimens increased up to 88% and 252% for the specimens RSC1 and RSC2 respectively. The author found that energy absorption of repaired specimens was more relative to control specimen because of no degradation during reversed cyclic loading, higher bearing capacity, and reduction in the pinching of hysteresis loops. With the reduction in the beam's height at the joint, energy dissipation was reduced up to 26% and 44% for the control and retrofitted specimens.

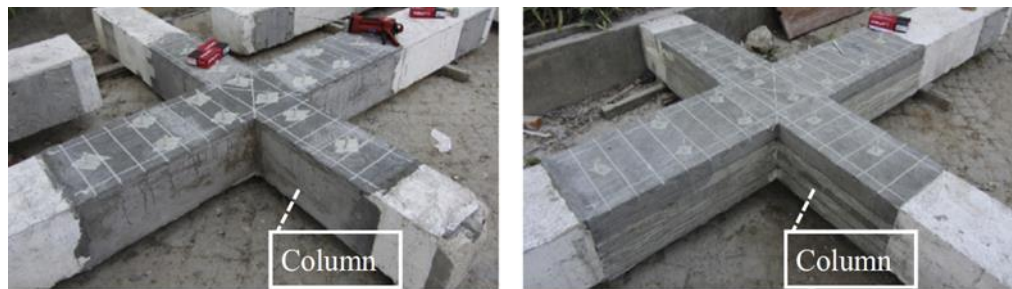
Figure 2-9 Pictorial view of retrofitted specimens [19]

Esmaeel et al. (2014) [19] repaired the severely damaged full-scale interior BCJs using strain hardening cementitious composites (SHCC) reinforced with CFRP. The concrete cover in the joint area of the specimen was removed and replaced by SHCC. Self-compacting SHCC layer was reinforced with CFRP laminates. Two different schemes of CFRP laminates were used to retrofit the damaged specimen. In scheme #1, the CFRP laminates were applied on front and back faces of the specimen, designated as JPA3-R. While in Scheme #2 all four sides of joints were strengthened, designated as JPB-R. These retrofitting schemes are shown in Figure 2-9. These specimens were subjected to reverse cyclic loading. The load-displacement response showed that the lateral load carrying capacity has been restored. JPB-R specimen dissipated more energy than JPA3-R and hence more effective. At 4% of drift, JPA3-R could dissipate only 44.4 kN-m cumulative energy which was 5% more than the corresponding value in the virgin state. However, cumulative dissipated energy of JPB-R was 53.4 kN-m showing an increment of 95% in comparison with the specimen in undamaged condition. JPA3-R had higher secant stiffness as compared to specimen JPA3 between the drift of 0.13% and 1.67%. Later on, secant stiffness of JPA3-R and JPA3 was almost similar. For Scheme #2, after 0.13% drift value results showed a slower degradation in secant stiffness than its undamaged specimen. Hence Scheme #2 was more effective.

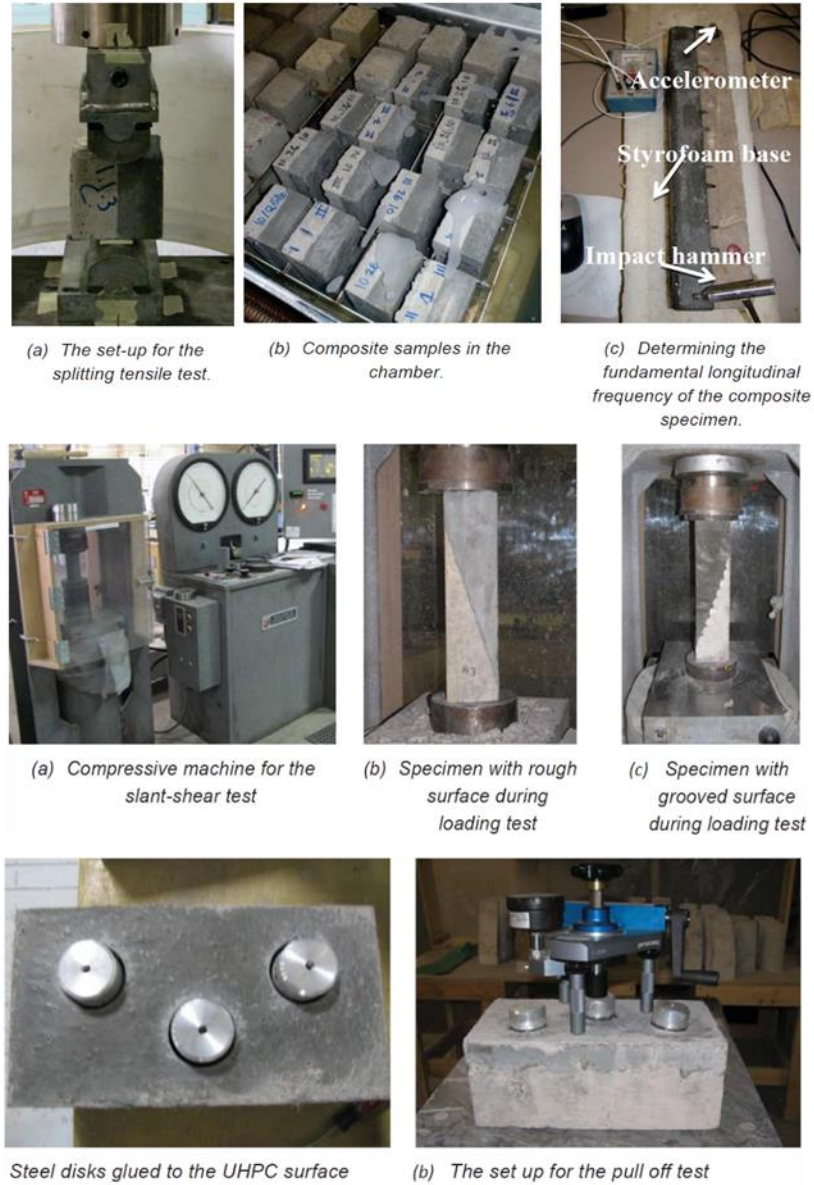
Figure 2-16 Test Setup of split tensile, slant-shear and pull off tests

It was reported that the bond performance between NCSS and UHPFRCC is successful. Results showed that saturated conditions of NCSS resulted into an excellent bond performance. The roughness degree of NCSS became irrelevant to obtain a good bond strength if appropriate wetting conditions took place[31].

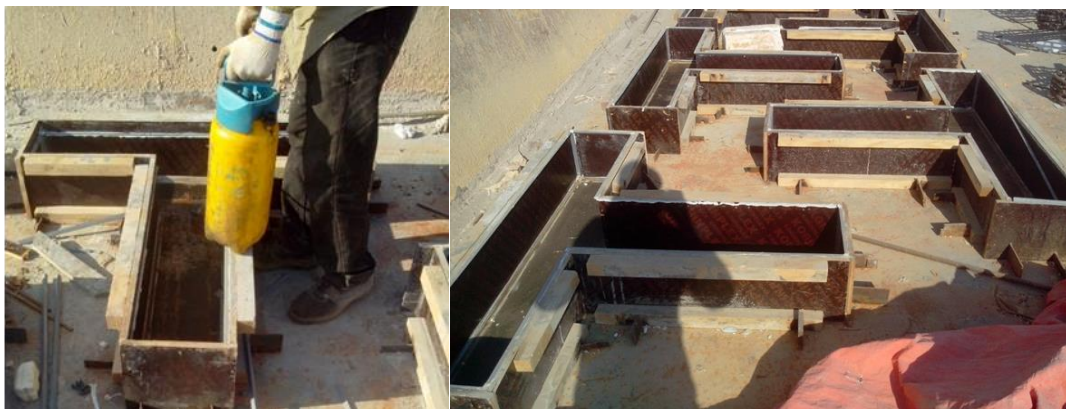
Figure 3-3 Preparation of wooden molds

New smooth surface plywood formwork of standard thickness 18 mm was used as a mold for casting the normal concrete. These molds were formed to produce specimens consisted of a column and beam with 200 x 250 mm cross section and the length of 1200 mm and 900 mm, respectively. In the formation of formwork, special attention was given to dimension, alignment and concrete cover. Before casting, inner sides of molds were properly cleaned and the gaps between the edges of formwork were sealed using silicon to prevent the flow of water from the concrete matrix. The preparation phase of the mold is shown in Figure 3-3. A thin layer of oil was sprayed on the inner sides of molds to facilitate the de-molding of RC specimens.

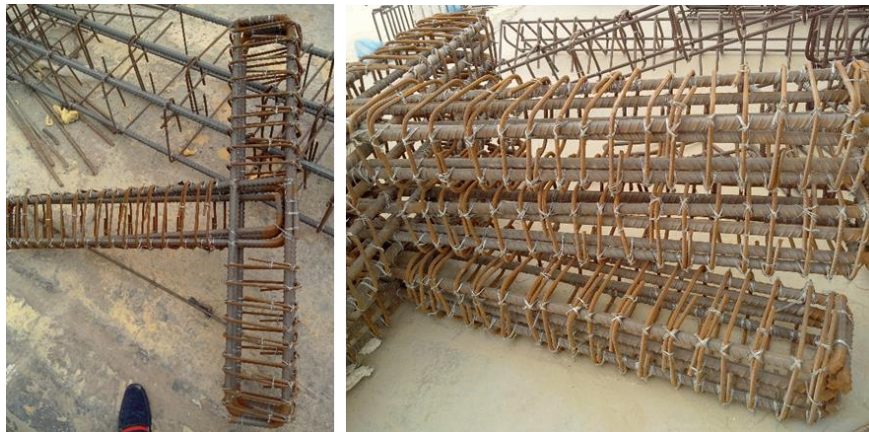
Figure 3-4 Steel cages for the test specimen

The reinforcement was cut and bent by commercial steel supplier according to bar bending schedule provided to them. The steel cages were assembled in the factory. For the construction of steel cages, steel wires were used to hold the main bars and stirrups in their position. Plastic spacers attached to steel cage were used to ensure the required concrete cover. Complete steel cages are shown in Figure 3-4. After the construction of steel cages, the location of strain gauges for monitoring the strain in the rebar was marked appropriately on the main and transverse reinforcements. After their formation, they were placed in the wooden molds. Figure 3-5 shows the placement of steel cage inside the wooden mold. The steel cage, settled in the wooden mold before casting, is shown in Figure 3-6. Before casting the concrete, the strain gauges were installed on the main and transverse reinforcement after cleaning and sanding the surface of the rebar to provide the flat surface. Strain gauges were attached using super glue and covered them using waterproof tape to avoid their damage from water and protect them from the impact of aggregates and vibrator during casting.

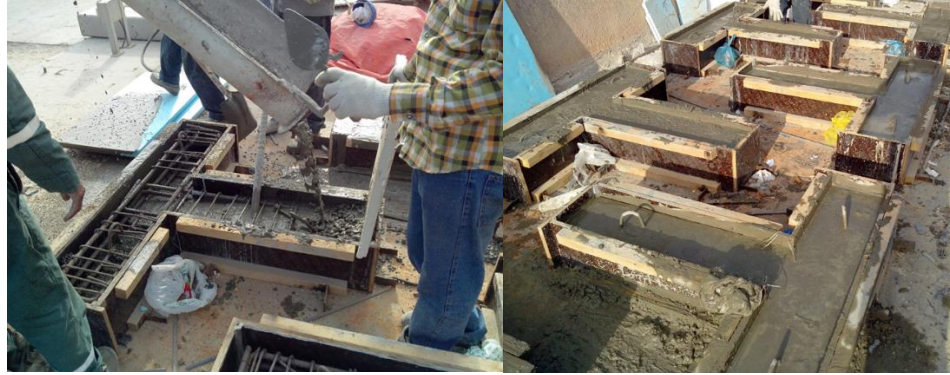
Figure 3-7 Casting of test specimens

The conventional concrete for casting was provided by “Saudi Ready-Mix Concrete Company”. All specimens were cast from the same batch. The concrete was poured directly into the molds from the truck. Small electrical poker vibrator was used to consolidate the concrete completely and leveling was done with the help of trowels to level an uneven surface as shown in Figure 3-7. For determining the material properties like concrete compressive strength and split tensile strength at the age of 28 days, standard size cylinders were cast from the same batch of concrete. After casting the concrete, BCJs and cylinders were covered with plastic sheets to prevent the loss of water that may result in the surface

cracks. After de-molding, specimens were cured using wet jute to avoid shrinkage cracks and premature stresses in the concrete.

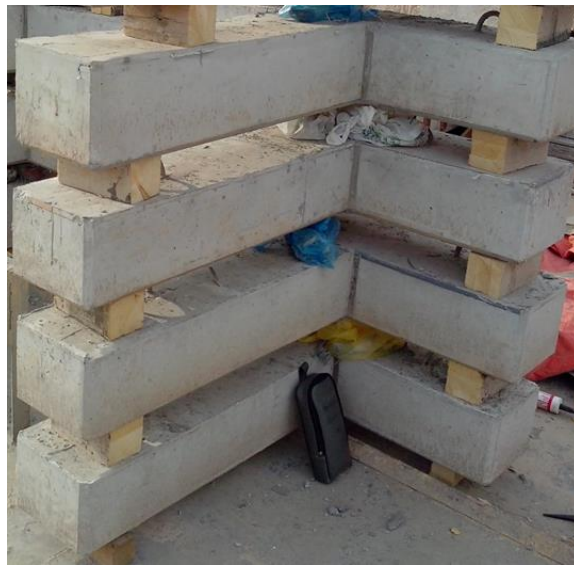
Figure 3-8 Test specimens at 28 days curing period

After completion of curing period (28 days), specimens were transported from the precast factory to Heavy Equipment Reaction Floor Lab of KFUPM as shown in Figure 3-8.

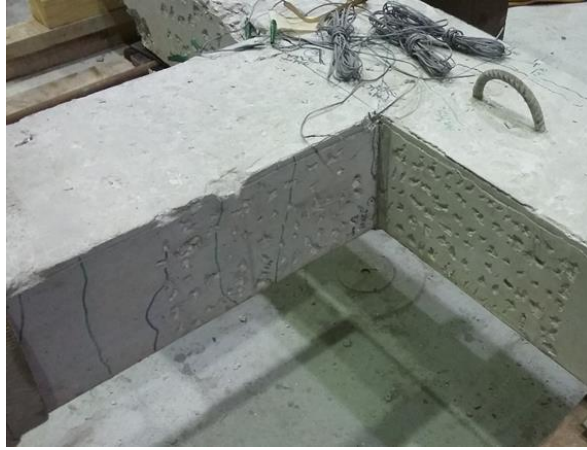
Figure 3-9 Chipped NCSS after surface treatment

The experimental work involves the post-damage repair and pre-damage strengthening of damaged and undamaged BCJs, respectively. In the former set, three severely damaged exterior BCJs designated as SP1, SP2, and SP3 were elected from a group of specimens that were tested in their virgin state in the ambit of the research program of MS thesis [38]. All specimens were similar regarding geometric and reinforcement detailing. The only difference between these specimens was Column Axial Load (CAL). For this group, Axial Load Ratio (ALR) varied from 0 to 0.57 and CAL was 0 kN, 200 kN, and 600 kN for units SP1, SP2, and SP3, respectively. These specimens were tested under monotonic loading and were loaded up to 100% of ultimate load carrying capacity at the beam tip in their virgin state to distresses their elements. These damaged specimens were repaired with state of the art magic material. These specimens were reinforced in the column, beam and joint region using UHPFRC jacket. The jacket was extended 250 mm from the joint region to the beam and columns, and this extension was equal to the depth of the element. Before application of UHPFRC jacket, the normal concrete substrate surface (NCSS) was made clean through brushing. For making the successful bond between NCSS and UHPFRC, some surface preparation techniques were available for the preparation of substrate surface such as chipped surface, sandblasted surface, and grooved surface. For the specimens of group 1, chipped surface slightly brushed with the dry condition was selected for surface preparation which includes the small holes produced by a hand drill. Figure 3-9 shows the NCSS after surface treatment.

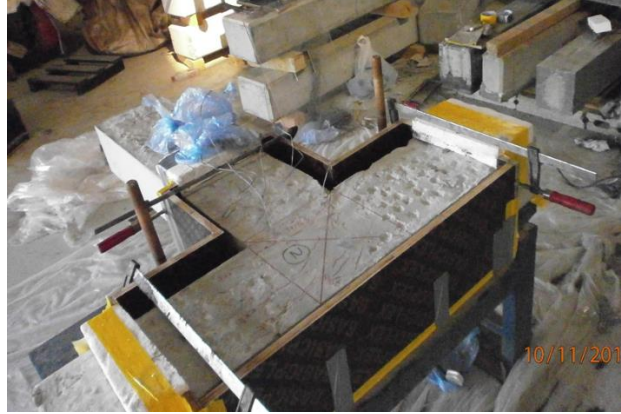
Figure 3-11 Specimen positioned inside the mold before UHPFRC jacketing

Smooth surface wooden molds were used for casting the UHPFRC jacket around the NC, as shown in Figure 3-10. The inner surface of the molds was cleaned and inside edges were sealed with silicon. To facilitate the demolding of UHPFRC jacket, a thin layer of oil was sprayed onto the inner surfaces before casting the UHPFRC. Figure 3-11 shows the damaged specimen after surface treatment positioned in the mold. The whole set-up of UHPFRC jacketing was placed on the vibrating table to provide small magnitude vibrations for the flow of UHPFRC if required. The equipment and material used for mixing and casting the UHPFRC will be discussed in section 3.6.3. Jackets were cast when specimens place horizontally. UHPFRC was poured around the damaged specimen inside the mold.

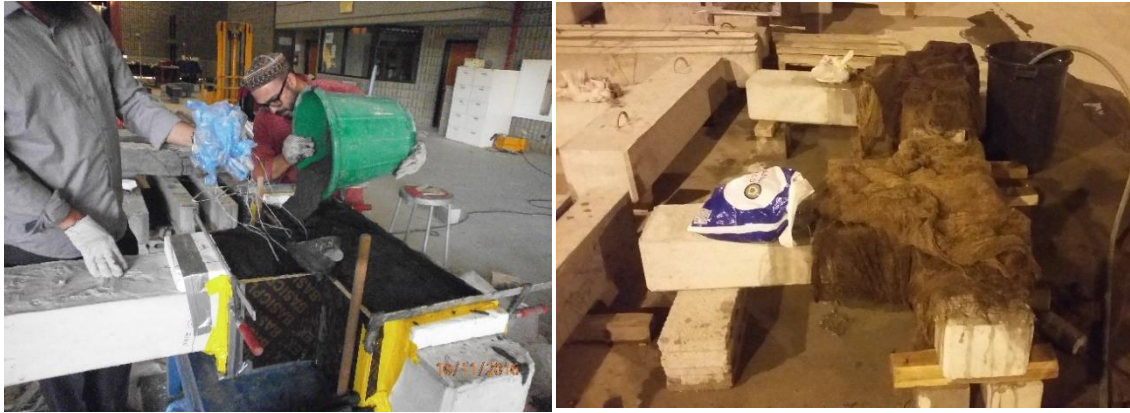
Figure 3-14 Casting and curing of UHPFRC jacket of repaired specimens

The column, beam, and joint region were encased in UHPFRC jacket of 30 mm thickness. The geometry and reinforcement details of retrofitted specimens are shown in Figure 3-12 and Figure 3-13, respectively. After casting the jacket, test units were covered with plastic sheets to prevent rapid loss of water. Repaired specimens were de-molded after 24 hours of casting. These specimens were cured for 28 days with wet burlaps. The pictorial view of specimen's repairing, jacket casting, and curing is shown in Figure 3-14.

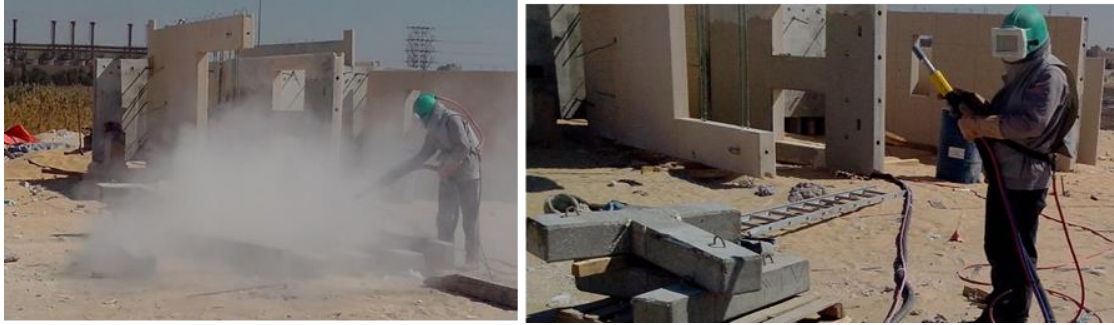
Figure 3-15 Sandblasting of BCJ's substrate surface

Group 2 consisted of four undamaged specimens. Of these, three specimens were strengthened using UHPFRC jacket before application of load, designated as TS-1, TS-2, and TSE. From the numerous surface preparation techniques, NCSS of specimens TS-1 and TS-2 was made rough through sandblasting technique up to medium level. Sandblasting of these specimens had been done at Prainsa Precast Factory, as shown in Figure 3-15. Figure 3-16 shows the strengthening process of units TS1 and TS2. The casting of UHPFRC jacketing was done in the same way as described in section 3.5.1. The geometry and thickness of UHPFRC jacket were same as described in section 3.5.1. Figure 3-12 shows the schematic view of strengthened specimen. Specimens upgraded using UHPFRC jackets were de-molded after 24 hours of casting. These specimens were cured for 28 days with wet burlaps.

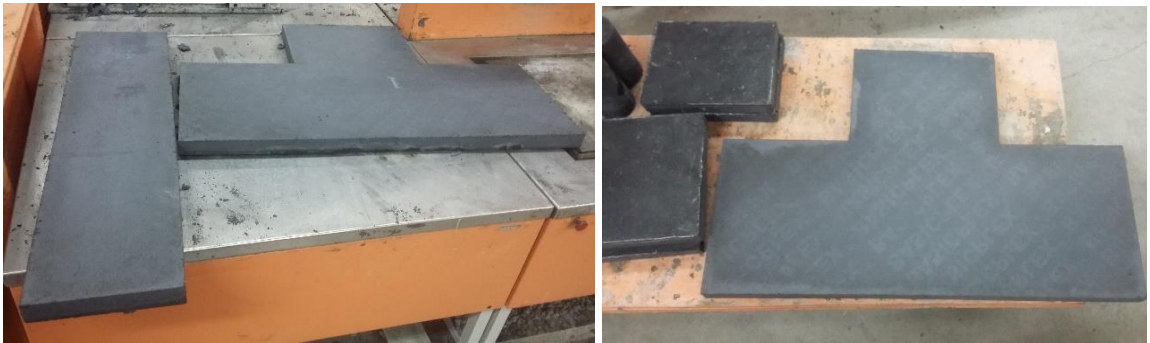
Figure 3-18 Precast UHPFRC plates

For the third specimen of this group, designated as TSE, the structural epoxy-bonding agent was used to attach the pre-fabricated UHPFRC plates without adopting any surface preparation technique. Instead of the in-situ casting of UHPFRC inside the molds, T, I and Square shape UHPFRC plates of 30 mm thick were cast using the wooden molds as shown in Figure 3-17 and cured for 28 days. These wooden molds were cleaned and sealed with silicon before casting. The wooden molds and UHPFRC-plates after de-molding are shown

in Figure 3-17 and Figure 3-18, respectively. These UHPFRC plates were applied to NCSS using 2-parts structural epoxy bonding agent named as Sikadur[®]-32 LP. It is moisture tolerant, structural two part bonding agent based on a combination of epoxy resin and special fillers. NCSS was cleaned using an angle grinder to obtain the surface that was sound, clean, dry and free from any cement lattice. Any loose or friable particles were removed to achieve a contaminated free and open textured surface. Before application of these plates, the NCSS was also made clean through compressed air, as shown in Figure 3-19 and Figure 3-21. The components A and B of Sikadur[®]-32 LP were mixed for 3 minutes using spindle attached to an electric drill. After mixing the components of epoxy, I-shaped UHPFRC plate was attached to back face of the column, as shown in Figure 3-19 and Figure 3-22 (a), followed by the square-shaped strips that were bonded to column and beam portions, as shown in Figure 3-19 and Figure 3-22 (b). In the end, T-shape plates were applied to the specimen covering beam, column, and joint region. Figure 3-19 shows the retrofitting process of specimen TSE. Figure 3-20 displays the 3-D view of TSE. The ambient conditions and temperature, as stated in product data sheet provided by the epoxy supplier, were maintained using two 500 watts halogen bulb, as shown in Figure 3-23.

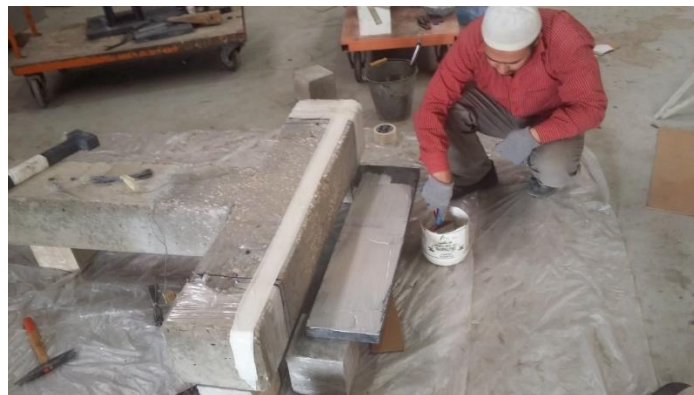
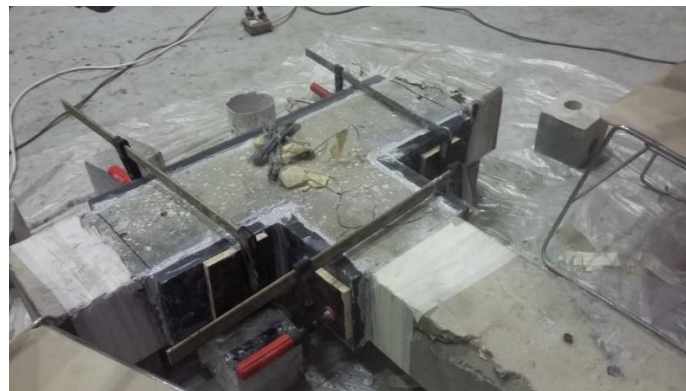
Figure 3-22 Strengthening of BCJ with pre-fabricated UHPFRC plates

(a) Attachment of I-plate

(b) Attachment of rectangular plate

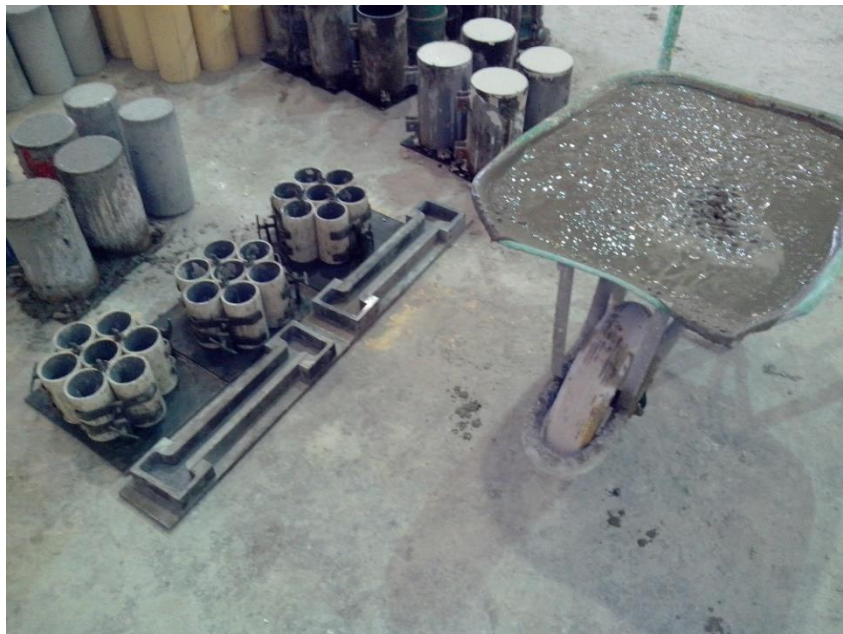
Figure 3-24 Sampling of concrete during Casting

Saudi Ready-mix Concrete Company provided the Normal concrete with a minimum design strength of 25 MPa. The slump of concrete before casting was 110 mm and the maximum aggregate size used was 25 mm. During the casting of BCJs, multiple cylindrical specimens of 75mm x 150 mm were cast from the same batch, as shown in Figure 3-24, for characterization and material modelling. For modelling the concrete in Finite Element solver, uniaxial compression test under monotonic and cyclic loading was performed. From this test, stress-strain behavior of the material, modulus of elasticity and Poisson's ratio were calculated which were used to characterize and model the material. In addition to compression testing, split cylinder strength test was also performed to determine the indirect tensile strength of concrete.

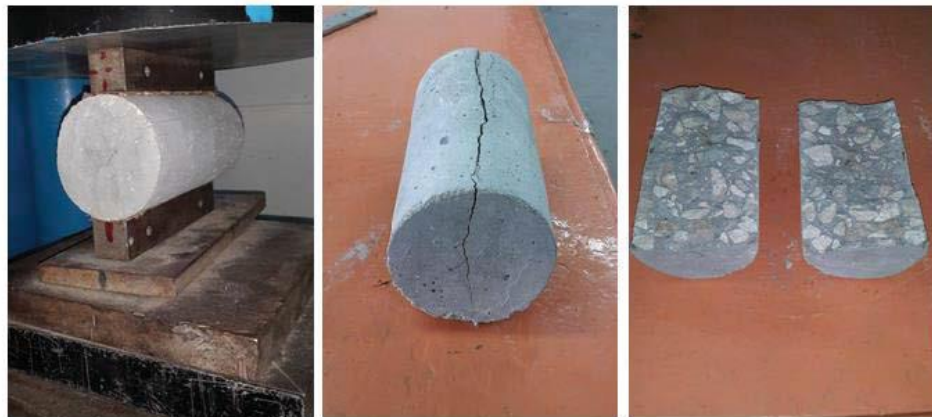
Figure 3-28 Test setup for Split tensile test (left) and failure mode (right)

Split tensile strength test was carried out on three cylinders for the measurement of the indirect tensile strength of concrete used for casting the specimens of group 2 while for the specimens of group 1, split tensile strength values were reported in MS thesis [38]. The test setup used for testing and specimen after testing is shown in Figure 3-28.

The strength value was determined in according to ASTM C496 [41]. Compression testing machine with a maximum capacity of 3000 kN was used for this test. Peak failure load was obtained from the machine and following formula was used to determine the indirect tensile strength of the concrete.

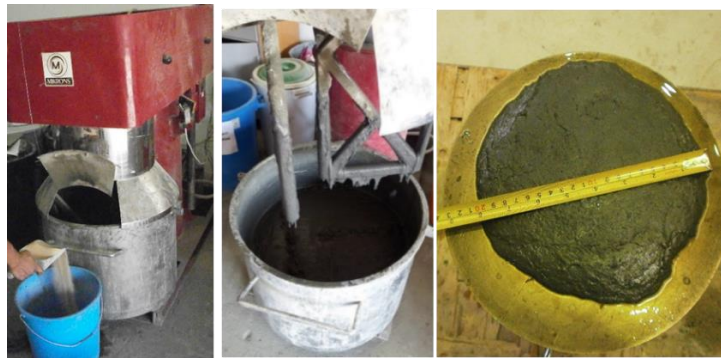
Figure 3-33 Planetary mixer (Left), UHPFRC mixture (Center) Flow Table Test (Right)

Locally developed and optimized mixture was used for strengthening and repairing of all BCJ specimens. Special equipment and procedure were used for the preparation of UHPFRC mixture. For the preparation of strengthening material, a high shear capacity mixer was required. The casting of UHPFRC was carried out in Concrete Lab, using horizontal pan mixer and average flow diameter was measured using flow table test, as shown in Figure 3-33.

- Around 13 minutes of first addition of water and HRWR agent mix, signs of the cohesive mix will be prominent and moisture traces will be visible in the mixture. Now add remaining water and HRWR agent mix and mix them for another 2 minutes. The mixture will start to flow at this stage.
- Dispense the steel fibers into the matrix and keep mixing for another 3-5 minutes until all fibers seem to be evenly mixed. The UHPFRC mixture is ready to perform spread flow test and strengthening the BCJs.

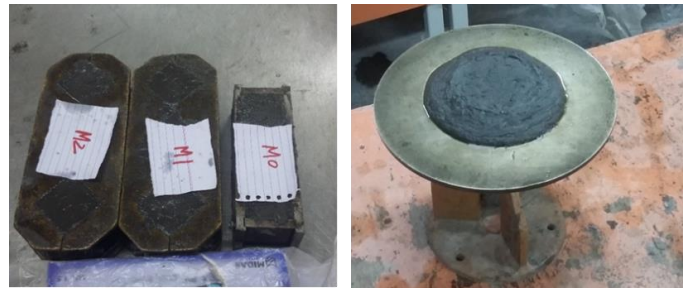
Figure 3-34 Casting of cubes (Left) and Flow table test (Right)

UHPFRC jacketing around all sides of BCJ specimens was one of the challenging tasks due to lower water-binder ratio. Four trial mixes had been prepared using the mixture design developed by Hakeem et al. (2011) [42] to obtain the maximum spread flow without compromising the mechanical properties. The variable parameters in these mixtures were the dosage of super plasticizers and water-binder ratio. Spread flow values were determined through flow table test and compression strength test was conducted on 50 mm cubes. For this purpose, UHPFRC mixture was prepared and 50 mm cubes were cast, as shown in Figure 3-34. Trial mixtures were tested for consistency. ASTM C1437 standard test method for measuring the flow of hydraulic cement was used to comply with the recommendation

outlined in Ductal reference TOO6 (Operating Procedure Flow Test). For this, the mini cone was filled with the mixture and removed slowly to allow the mixture to flow evenly on the table and then flow table was dropped 20 times and its average flow diameter was recorded, as shown in Figure 3-34. The compression strength test was conducted on 50 mm cubes. The details of these mixes and test results are given in Table 3-8.

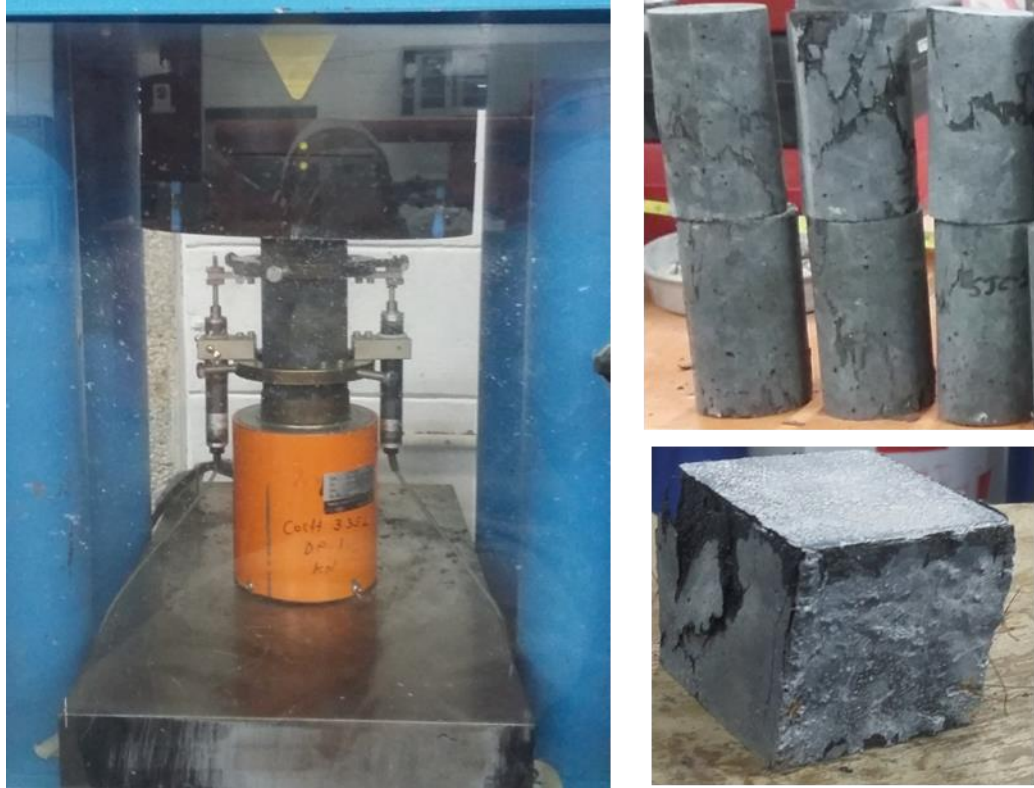
Figure 3-36 Test set-up for Compressive strength test (left) and Failure modes of specimens (right)

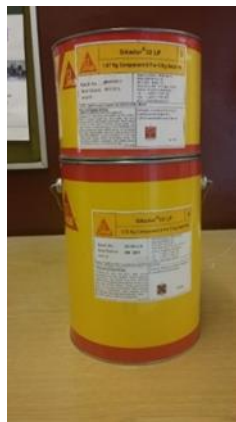
Figure 3-41 Packaging of Sikadur® -32 LP

For upgrading the BCJ sub-assembly, pre-fabricated UHPFRC plates were attached to NCSS using Sikadur®-32 LP. It is available in 5kg (A+B) package, as shown in Figure 3-41. It is 2-part structural epoxy bonding agent and adhesive for concrete elements. The mechanical properties, as given in product data sheet are described in Table 3-12

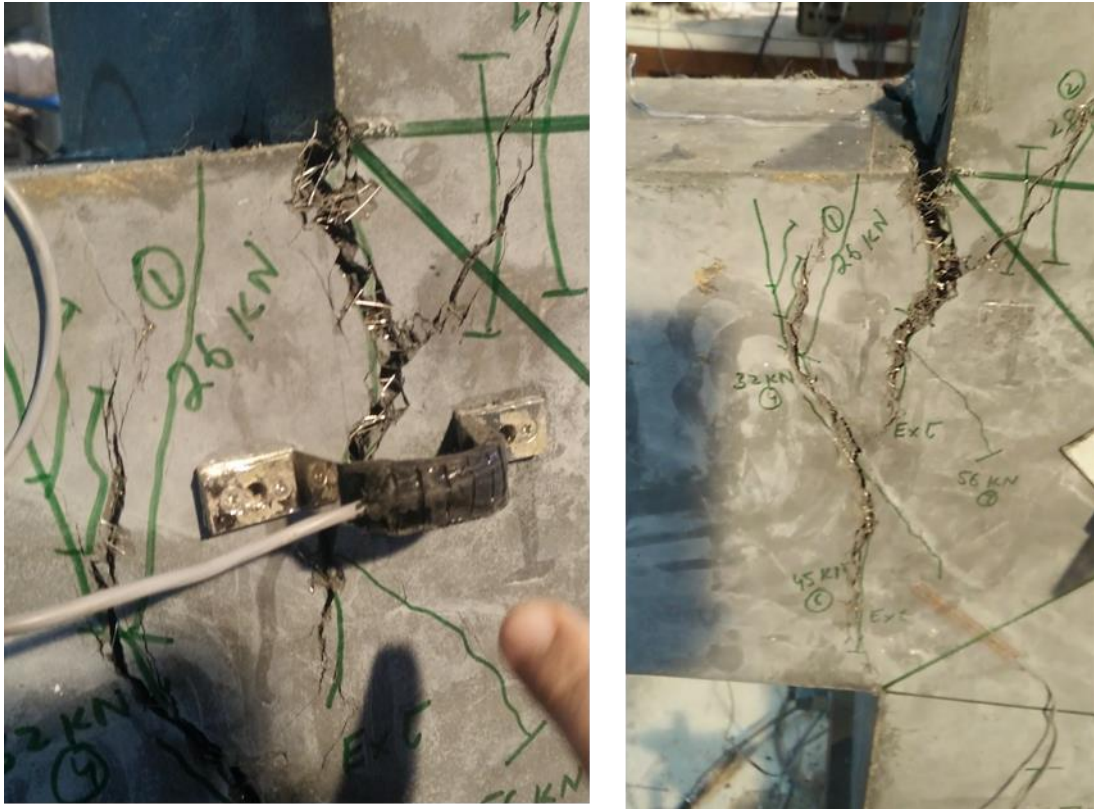
a) Crack pattern of Specimen SP1-R

flexural failure of beam at the beam-joint interface with the yielding of beam main reinforcement.

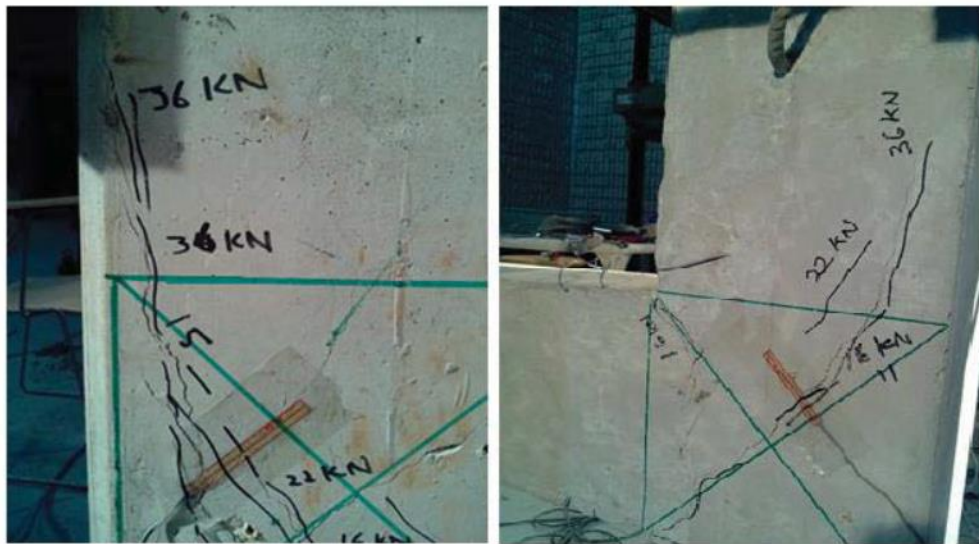
b) Crack pattern of Specimen SP1

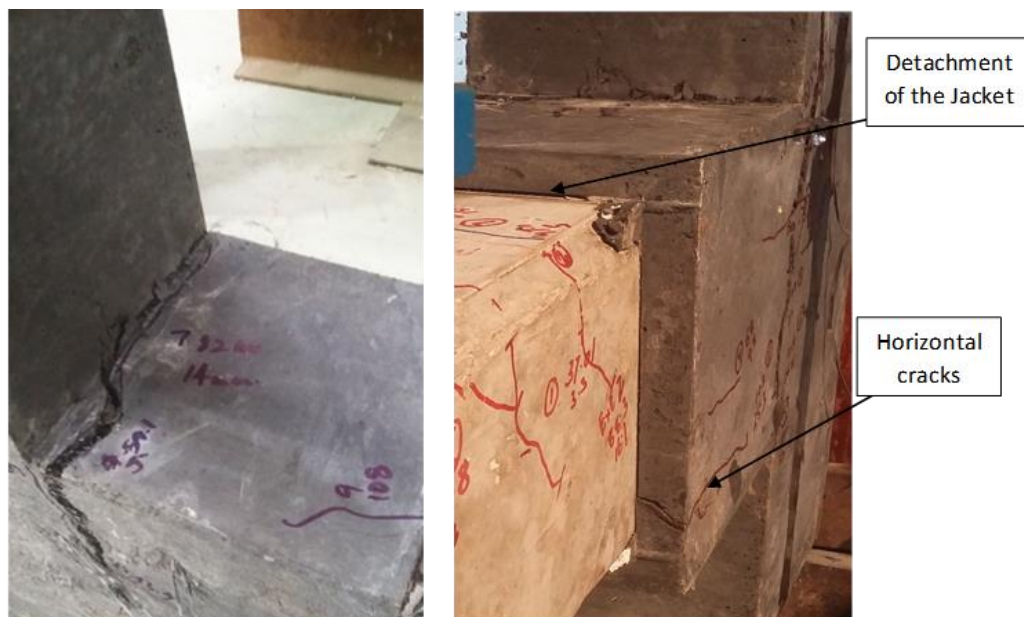
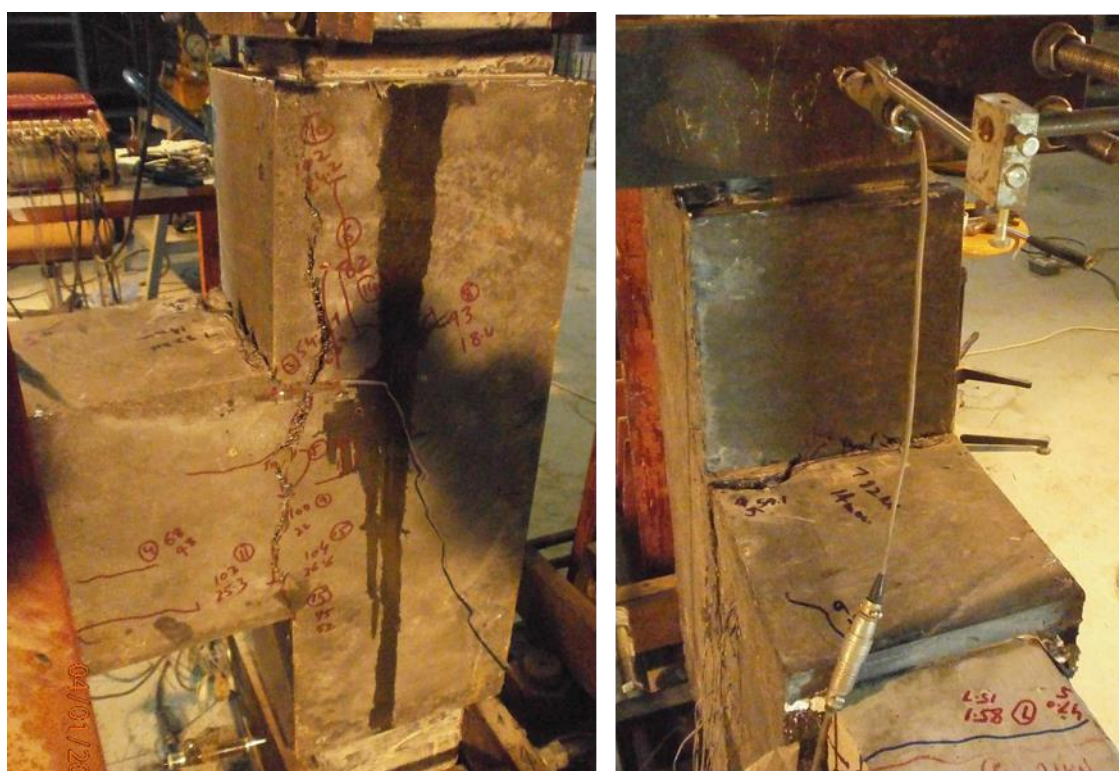
Figure 4-15 Continued

In the virgin state, the first series of cracks appeared in the beam at a load of 17 kN corresponding to displacement 1.03 mm which did not develop significantly in the subsequent loading history. The Second series of cracks consisted of inclined cracks and occurred in the joint at a load of 38 kN and displacement of 4.11 mm. With the further increment of load, inclined cracks developed at 75^0 . These cracks increased in length and width and resulted in the failure of a joint in shear. Maximum strain in beam reinforcement was reported to be $986 \mu\epsilon$ which was far less than the yield strain. Therefore, the specimen failure mode was brittle joint shear failure without yielding of beam reinforcement. Contrariwise, retrofitted specimen SP3-R, when tested under same loading history, showed vertical flexural cracks at beam joint interface and horizontal cracks near the edges of jacket. The major failure was registered due to vertical flexural cracks at the beam-joint interface. The maximum strain in the beam reinforcement was found to be $5629 \mu\epsilon$. It is essential to notice that the application of 30 mm thick UHPFRC jacket delayed the initiation of cracks. Secondly, no major cracks had been found in the joint panel and cracks were shifted from the joint panel to beam or beam joint interface. Thirdly, the strain in the beam longitudinal reinforcement was more than the yield strain of the rebar resulting in the formation of a plastic hinge, concentrated at the beam-joint interface. The condition of specimens SP3 and SP3-R after the completion of the test is shown in Figure 4-15.

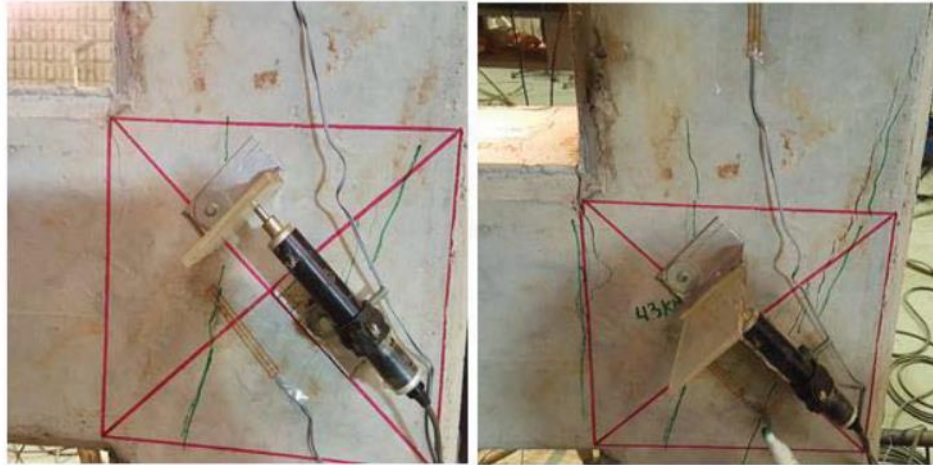
b) Crack pattern of Specimen SP3

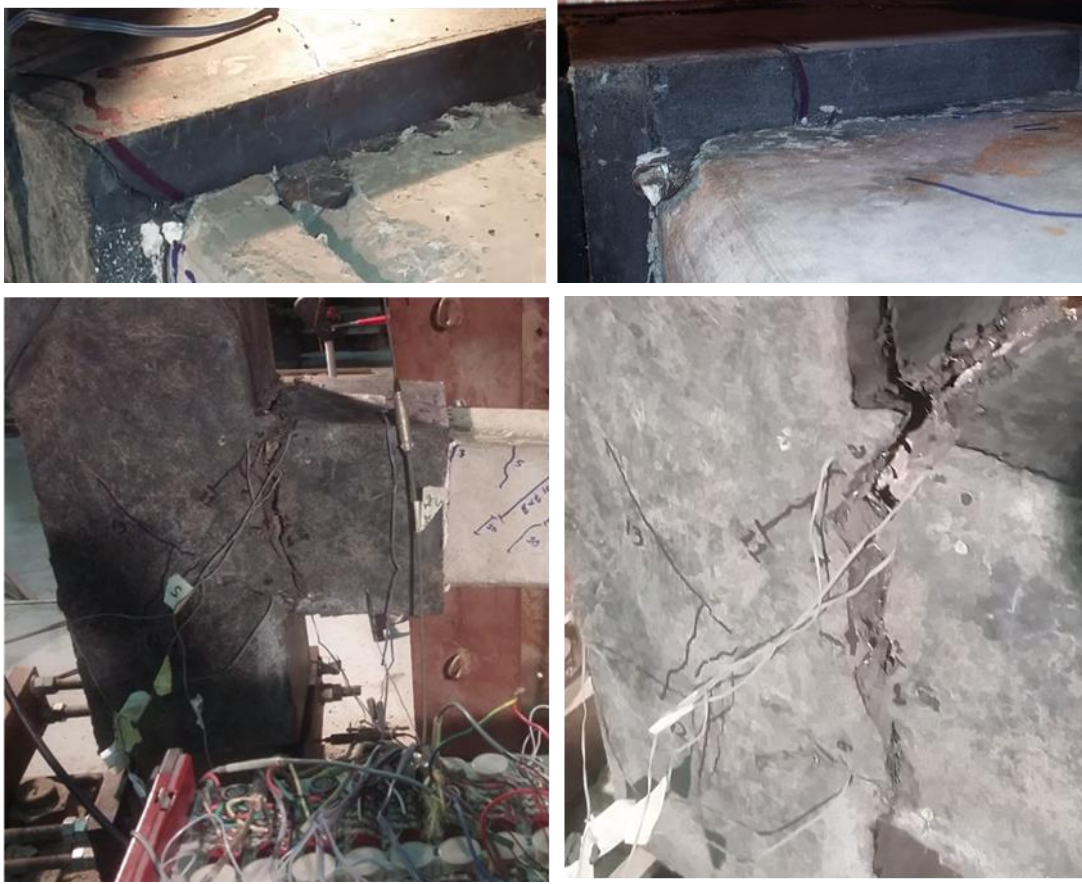
Figure 4-37 Development and propagation of cracks in specimen TS1

At the 14th cycle at $\pm 1.6\%$ drift, when the specimen reached the peak strength, the damage was observed on the edges and corners of UHPFRC-jacket surrounding the inner face of upper and lower column and upper and lower face of the beam, as shown in Figure 4-37. These cracks developed in the subsequent load history. As a result, the detachment of UHPFRC-jacket started to occur at a drift of about $\pm 2.5\%$.

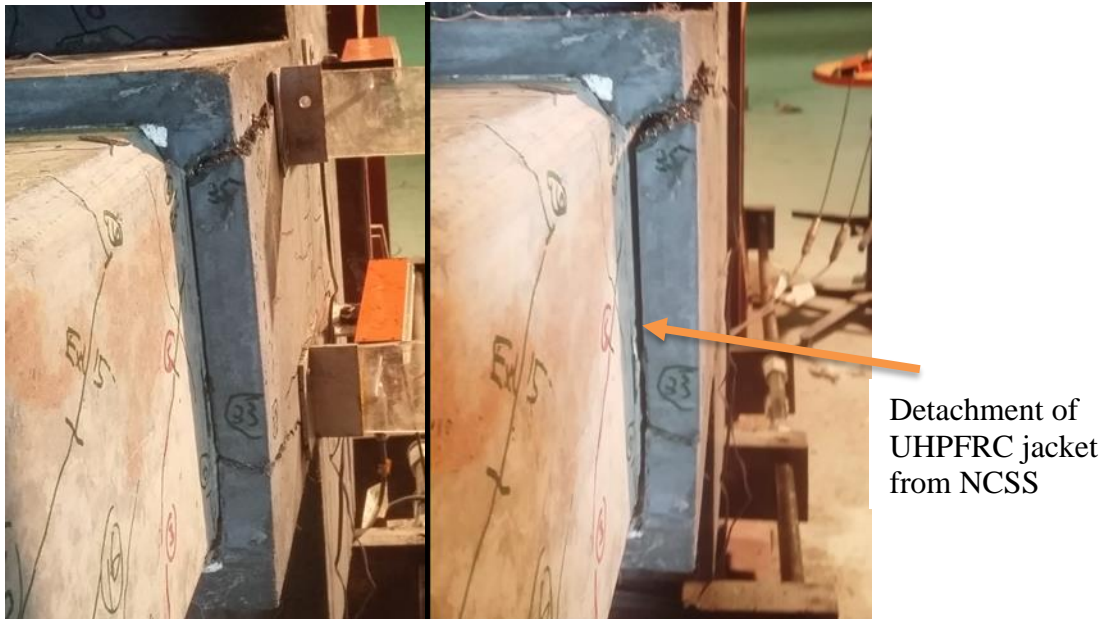
Figure 4-39 Back side of the beam after the test completion and detachment of UHPFRC for test unit TS2

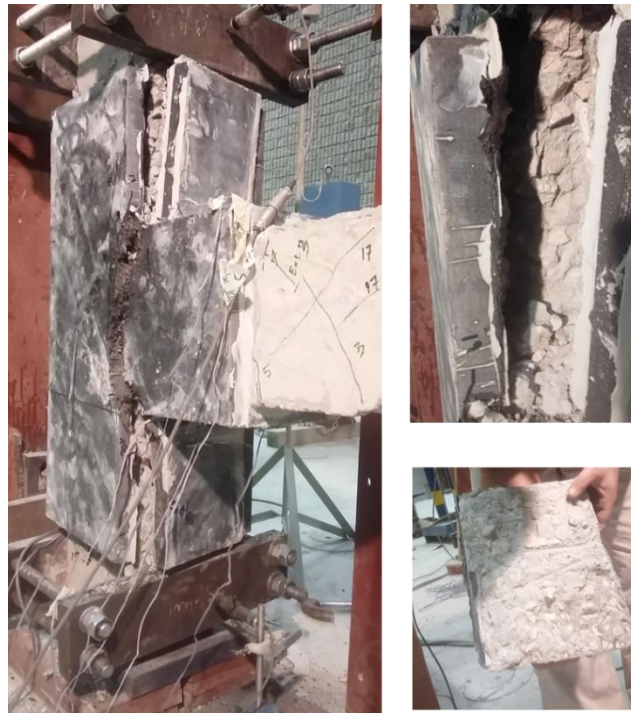
Figure 4-45 Specimen TSE after test completion (LEFT) and Separation of plates with concrete cover (Right)

developed due to the imposed displacement at beam tip as a single unit. At the 19th cycle at -2.22% drift, the contact between T-plate and rectangular plate over lower column was effected by the formation of cracks in the epoxy, as shown in Figure 4-42. This crack developed in the subsequent loading history and separation between UHPFRC plates started to occur at edges. In the positive excursion, at a 21st cycle at +2.8% drift, cracks appeared at the contact between T-plate and rectangular plate over an upper column, as shown in Figure 4-43. The performance of the whole assembly was severely damaged due to the formation of localized vertical cracks at the beam-joint interface and complete separation at one edge of T-plate from the other plates, as shown in Figure 4-45. As test continued, T-plate did not react and deform with the other assembly. Therefore, all stresses were taken up by the RC core assembly at front and back face of a unit at the 22nd cycle at $\pm 3.1\%$ drift, corresponding to a load of 79 kN. Control specimen TC showed the maximum capacity of 49.07 kN. RC core-assembly could not bear the stresses imposed by a load of 79 kN and T-plate with the cover of RC core assembly was pulled out with the thrust as it is resisted by the contact between T-plate and I-plate on the other edge. Therefore, a chunk of concrete along with UHPFRC plate was separated out from the assembly and resulted in the sudden reduction in the strength of the test unit. The small rectangular plates attached to the inner face of a top and a bottom column showed the same behavior. The condition of the specimen after the completion of the test and complete separation of UHPFRC plate with concrete cover is shown in Figure 4-45.
